Zeus Design 2 Joystick Inspection and Software Reflash

NOTICE
Revised August 2018. This bulletin supersedes the previous bulletin number 2017-62, July 2017.

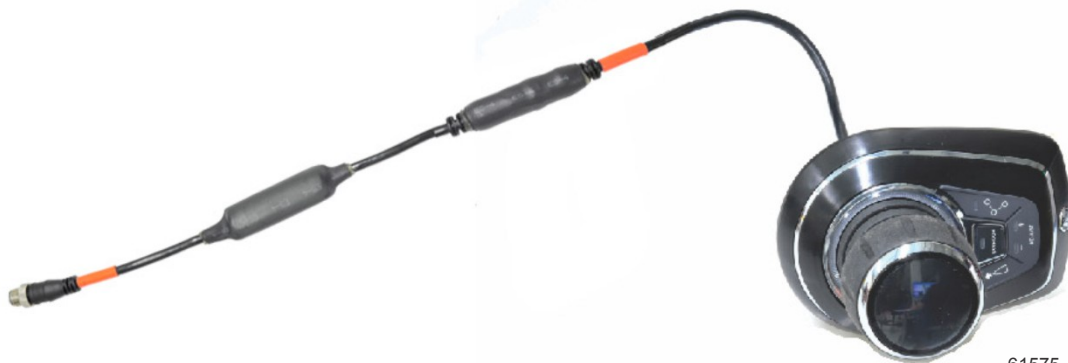
If the joystick is equipped with the external noise suppressor, replace the joystick/suppressor assembly. The following two images show the differences between the two designs.

Joystick with external noise suppressor

IMPORTANT: Do not remove the external noise suppressor assembly from the joystick. If additional length is needed to accommodate the shorter replacement joystick lead - in addition to the joystick, order extension harness 879171T01.

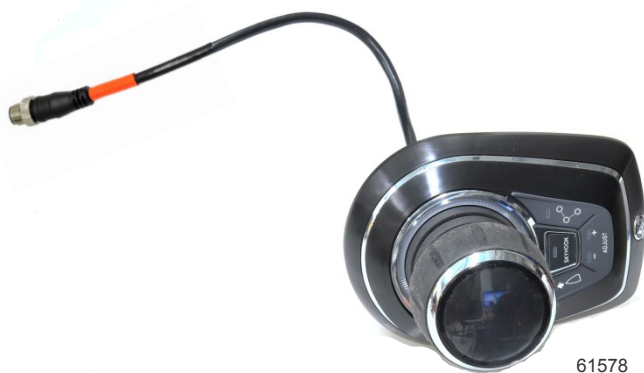
Joystick with internal noise suppressor
