Service Bulletin

Bulletin No. 2010-68
CMD 2010-08

Leak at Discharge Seacock—Zeus Pod

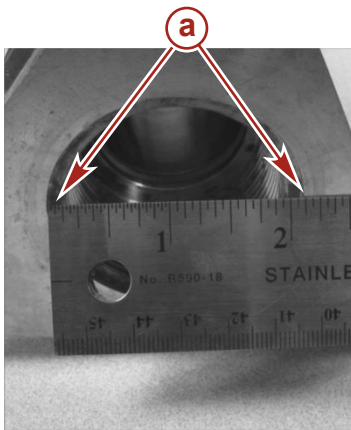
Discharge seacocks with a counterbore diameter of 54 mm (2.125 in.) as shown on the left in the picture below do not need to be replaced.

- Discharge seacock mounting surface**
- a -** Seacock counterbore with 54 mm (2.125 in.) diameter
 - b -** Seacock counterbore with 63.5 mm (2.50 in.) diameter

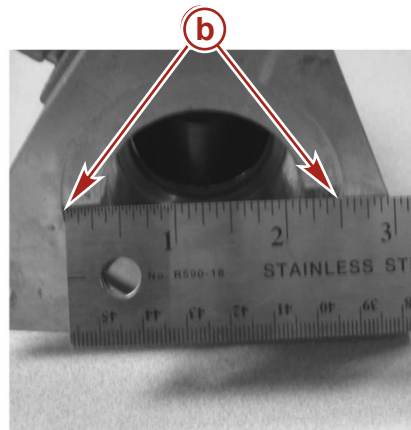
Discharge seacocks with a counterbore diameter of 63.5 mm (2.50 in.) as shown on the right in the picture below must be replaced.

For complete seacock removal and replacement procedures, refer to **Cummins MerCruiser Diesel Service Manual #52—Zeus 3000 Series Pod Drives**.
