Service Bulletin

Bulletin No. 2010-71
CMD 2010-11

Steering Actuator Inner Oil Seals

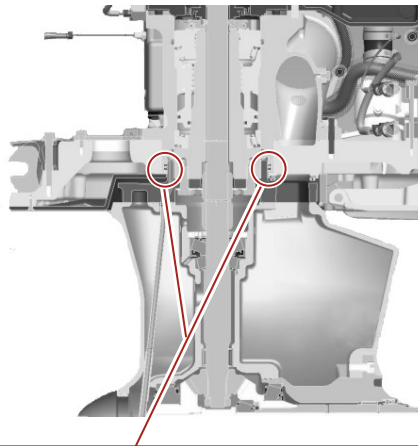
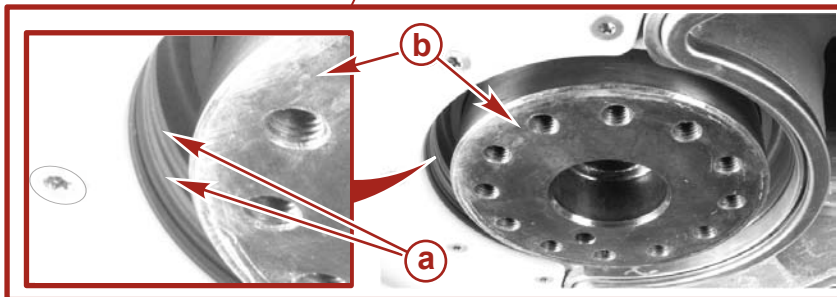
44058

Zeus drives use two seals between the king pin adapter plate and the steering actuator housing. These steering actuator inner oil seals keep gear lube in the drive and water out of the drive at the swivel joint of the king pin adapter and the steering actuator.

- a - Inner oil seals
- b - Steering actuator

A leak at this joint will cause the lube level to rise continually in the gear lube monitor. The lube will have a milky appearance because of water mixing with the gear lube. In some cases, the gear lube may be pushed out of the cap on the gear lube monitor.

Cummins MerCruiser Diesel now offers replacement seals for the steering actuator housing. The inner oil seals are now available separately and are serviceable if a leak is detected between the kingpin adapter plate and the steering actuator housing.

1. If the drive holds pressure and yet the lube is milky and the level is rising, the steering actuator inner seals should be replaced. Inner oil seals may hold pressure when tested, then leak during vessel operation. Leaking seals must be replaced. Service literature has been updated and provides the procedures necessary to replace the seals.
2. If the drive assembly does not hold pressure, remove the gear housing and pressure-test the gear housing. This test will determine whether the problem is with the gear housing or with the steering actuator seals. If the leak is with the gear housing, repair according to the service manual. The steering actuator seals are not the source of the problem.
