Replacement Distributor Cap on MerCruiser MPI Engines With HVS Ignition Systems

Models Covered	Serial Numbers
All MerCruiser V8 engines with HVS ignition systems	0M300000 and above

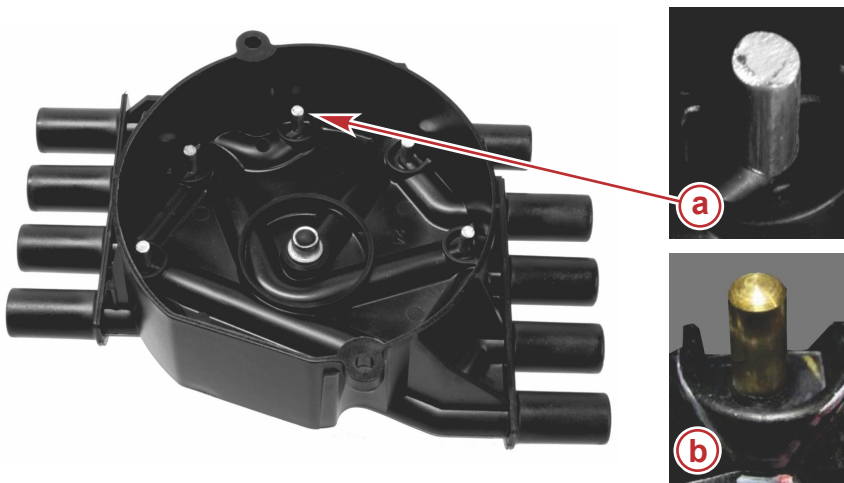
48515

- a -** Good: Distributor caps with aluminum conductor (silver color)
- b -** Needs to be replaced: Distributor caps with brass conductor (gold color) and box dates between January 1, 2011, and May 24, 2011, only.

MerCruiser has received reports of a misfire condition occurring after recent installation of service replacement distributor caps that have brass conductors. The misfire typically begins to occur after 20 minutes of engine operation.

For parts already installed: Replace the part and file a warranty claim for parts and labor (see **Warranty** below).

For parts not installed but in dealer inventory: If the box date code is between January 1, 2011, and May 24, 2011, and the distributor cap uses brass conductors, file a warranty claim for parts only.
