## Incorrect Ignition Timing on 3.0L TKS Engines

Models Covered	Serial Number Or Year
3.0L TKS Sterndrive Engines	2A013726–2A032399

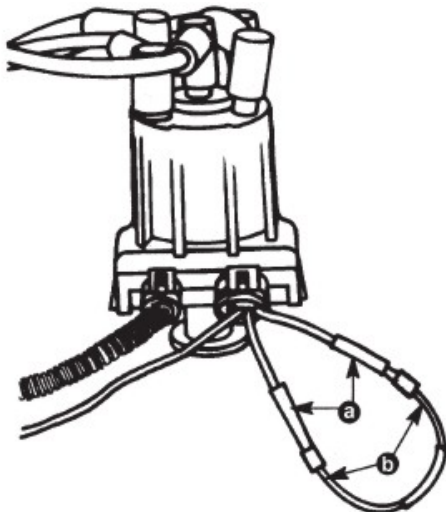
42953

- a - Purple/white distributor leads
- b - Jumper lead

1. Connect an inductive timing light (Quicksilver part number 91-99379 or similar) to the Number 1 spark plug wire.
2. Start engine and run at idle speed until it reaches normal operating temperature.
3. Install a jumper wire between the two purple/white leads on the distributor. Use Quicksilver part number 91-818812A1 or fabricate a jumper wire using a 6 in. section of 16 gauge wire with two male bullet terminal ends connected.

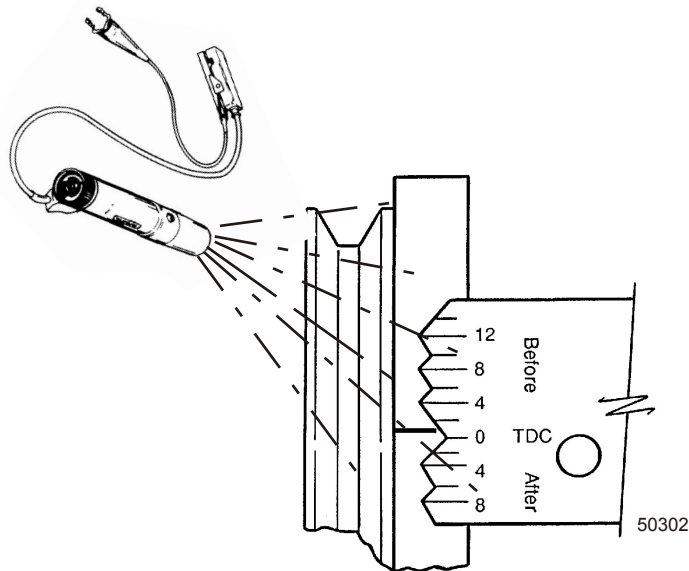
The ignition timing has been set in error to 8–12° after top dead center.

The correct specification for base timing on this engine is 2° after top dead center.

5. Aim the timing light at the timing tab, located on the timing gear cover and crankshaft torsional damper. Check the timing.

6. **If timing is found to be set at 2° after top dead center** - Shut off the engine and remove the jumper lead from the distributor and connect the shift interrupt switch to the engine harness bullet connectors. Mark with a white paint pen on the top of the coil wire boot at the center post of the distributor cap to indicate that the correct ignition timing has been verified.
7. **If timing is set at 8–12° after top dead center:**
- Loosen the distributor clamp bolt, and rotate the distributor body as required to align the indicator mark on the damper and the 2° after top dead center mark on the timing tab.
  - Tighten distributor clamp bolt.
  - Check location of the timing mark with the timing light.
  - Repeat steps a–c until the timing mark stays at 2° after top dead center.
8. Stop the engine.

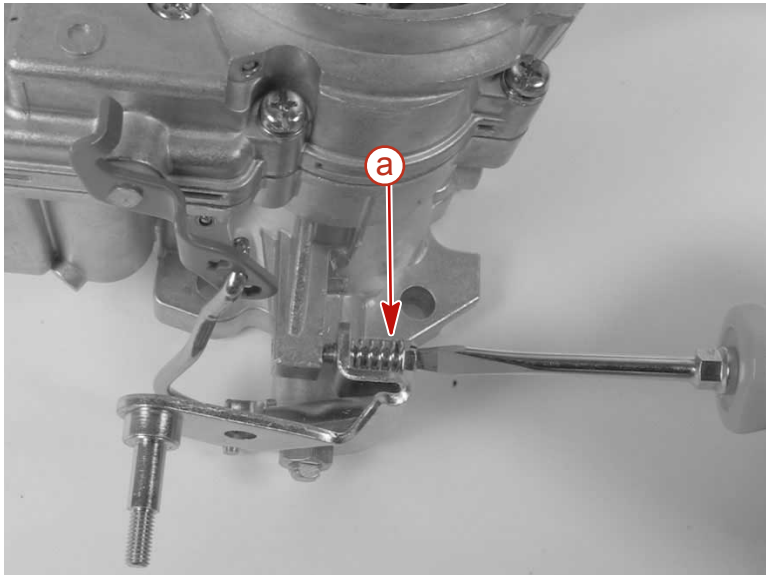
**a** - Idle speed set screw

10. Remove the jumper wire from the two purple/white wires on the distributor.  
**IMPORTANT: Engine must be at operating temperature and boat must be in the water to set the engine idle speed correctly.**
11. Start the engine and adjust the idle speed, using the idle speed set screw, to 650–700 RPM in forward gear.
