Worm Type Hose Clamp Ends and Edges - Laceration Warning

Models Covered
Mercury SDI, TDI, and QSD Diesel Engines

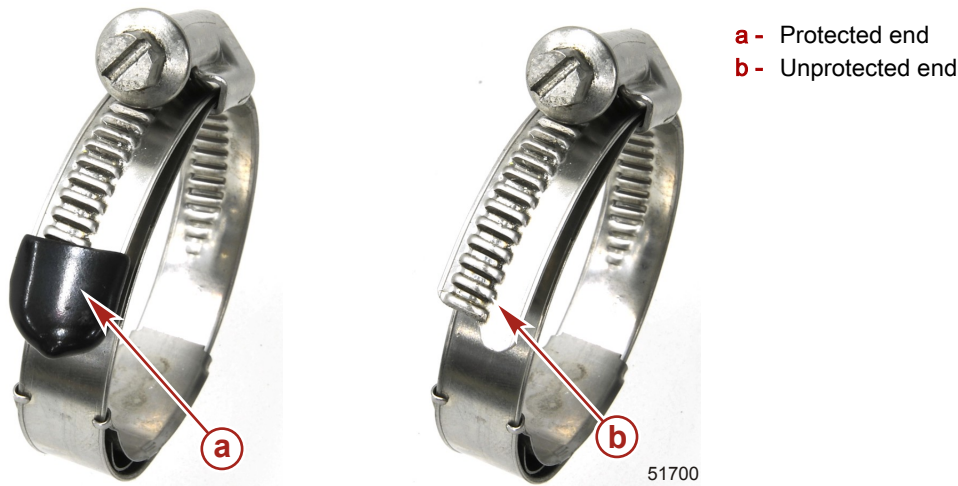
Some of the models above may have unprotected sharp ends on worm type hose clamps. These exposed sharp ends can cause a laceration if they come in contact with a part of the body during servicing, inspection, or maintenance of the power package.

If uncovered hose clamp ends are found, install the appropriate hose clamp end cover part number listed below.

Qty.	Description	Part Number
1	Cover, hose clamp end (1/2")	8M6500037
1	Cover, hose clamp end (1/4-5/16")	8M0074363
