## MerCruiser Emissions Control Engines Equipped with Generation III Cool Fuel Modules

### Models Affected

Models Covered	Serial Number Or Year
MCM Bravo Sterndrive MPI EC Engines	0W060000–2A437084
MerCruiser Inboard MPI EC Engines	0M398372–2A437084
MerCruiser EC Ski Engines	1A090000–2A437084
MerCruiser 350 Scorpion EC Engines	0W698433–2A437084
MerCruiser 377 Scorpion EC Engines	1A091488–2A437084

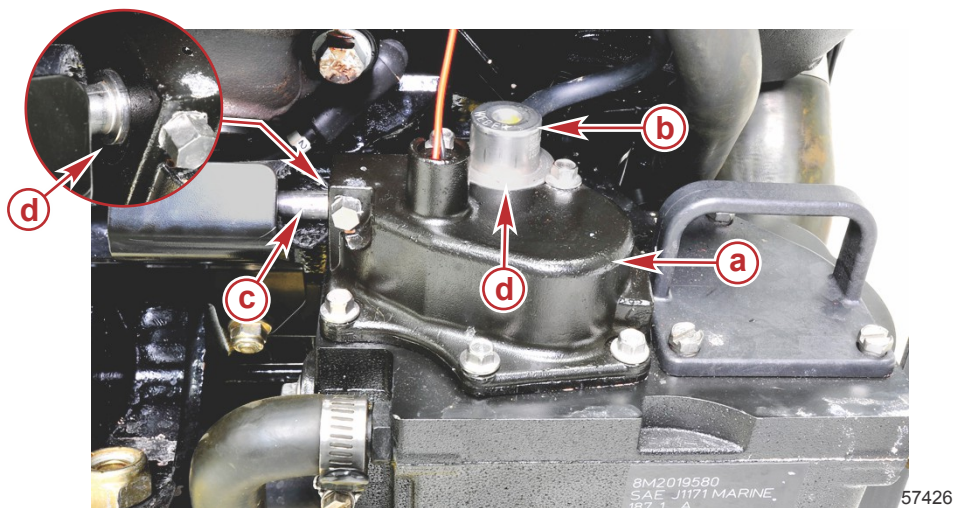
Paint delamination below the fuel pressure regulator on some Generation III Cool Fuel module top covers may cause performance issues, emissions related faults, or fuel weepage at the fuel pressure regulator or fuel module discharge line.

If you encounter fuel weepage, thoroughly inspect the areas around the fuel pressure regulator, discharge fuel line, and below the Gen III Cool Fuel module for the accumulation of fuel residue that would indicate the condition as described.

- Cool Fuel module**
- a** - Cool Fuel module top cover
  - b** - Fuel pressure regulator
  - c** - Discharge fuel line
  - d** - Inspection points

Replace the Gen III Cool Fuel module top cover, top cover seal, fuel pressure regulator, and the discharge fuel line quad ring if signs of fuel weepage, or paint delamination are observed at the inspection points described in this bulletin.

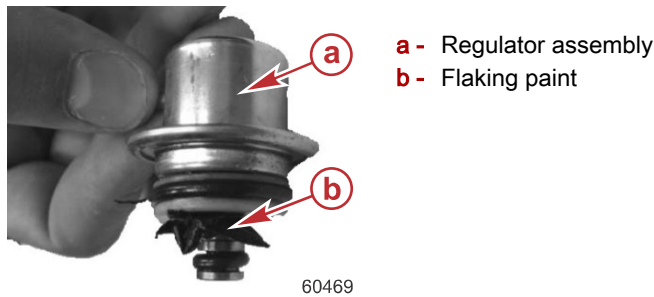
1. Remove the regulator from the top cover and look for paint particles or flaking paint caught in the regulator screen.

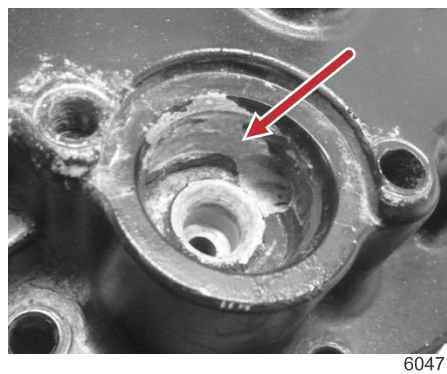
2. Inspect the top cover and regulator seat for evidence of deterioration, paint particles, and flaking paint.

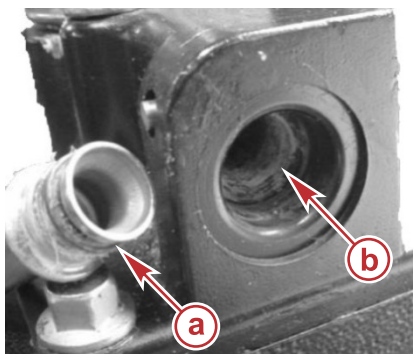
3. Remove the discharge fuel line. Inspect the quad ring and the condition of the fuel line bore for missing paint.

- a** - Discharge fuel line and quad ring  
**b** - Discharge fuel line bore

**IMPORTANT:** Do not reuse discharge fuel line quad ring. The quad ring must be replaced prior to discharge fuel line installation.
