Official Recall Notification U.S. Federal Boat Safety Act

Mercury Diesel Vessel Sensor Harness Replacement

If you are not comfortable with performing this inspection, or have confirmed that your vessel is equipped with DTS, contact your authorized Mercury dealer to schedule a service appointment. Be sure to mention Mercury Diesel Service Bulletin 2016-66.

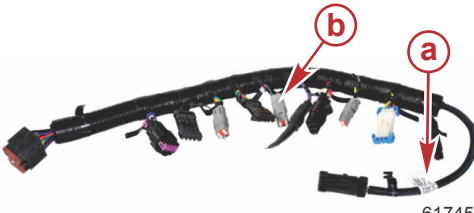
<p>61745</p> <p>a - Harness P/N label—8M3000209 b - Accessory relay drive connector (not used)</p>

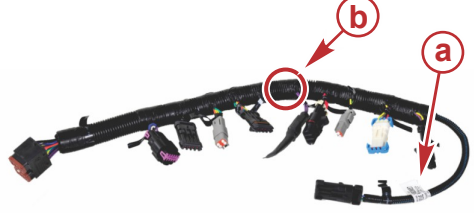
<p>61746</p> <p>a - Harness P/N label—8M2100588 b - Accessory relay drive connector removed</p>
3.0L TDI V6, 4.2L TDI V8

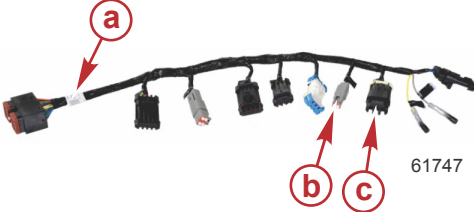
<p>61747</p> <p>a - Harness P/N label—8M2100302 b - Seawater flow connector (not used) c - Shift anticipate connector (not used)</p>

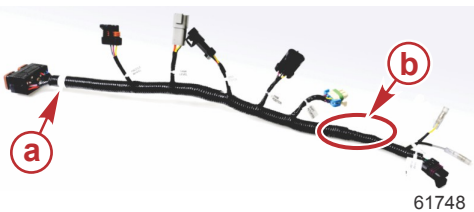
<p>61748</p> <p>a - Harness P/N label—8M2100575 b - Seawater flow and shift anticipate connectors removed</p>

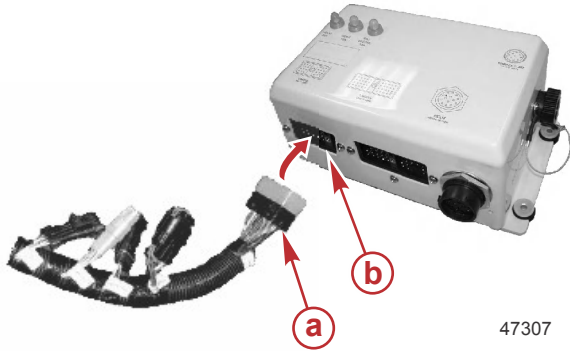
Mercury Diesel VIP vessel sensor harness connection

- a - Vessel sensor harness
- b - VIP connection location

3. Unplug all auxiliary sensors and devices from the harness. Loosen the Allen retaining screw and unplug the 24-pin connection from the VIP, VAA, or extension harness.
4. Connect the new vessel sensor harness 24-pin connector to the VIP, VAA, or existing extension harness. Tighten the Allen retaining screw to secure the connection.
5. Reconnect all auxiliary sensors and devices to the new vessel sensor harness, making sure all connectors seat properly.
6. Start the engine and verify function of the DTS shift actuator, trim sensor, and any other auxiliary sensors that are connected to the harness.

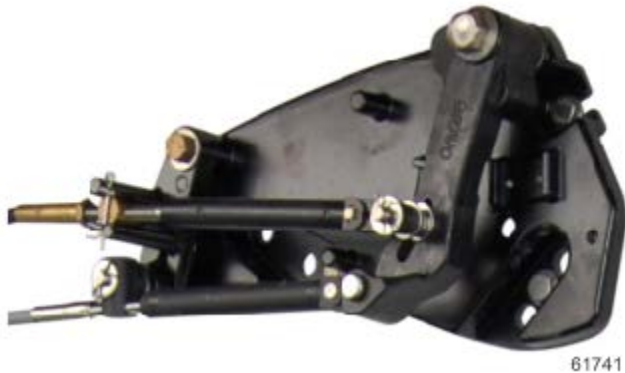
The mechanical shift plate will have two mechanical cables attached to it.

If this type of shift plate is present, no service activity is required. Please contact Mercury Marine Customer Assistance at 1-920-929-5040 to inform us that your vessel is not affected by this campaign.
