MERCURY
PERFORMANCE OUTBOARDS

No. 91-6

Mercury Hi-Performance Water Pick-up Hole Inspection on CLE Gear Cases

2.5 CARB/2.5 EFI/2.5 EFI Offshore

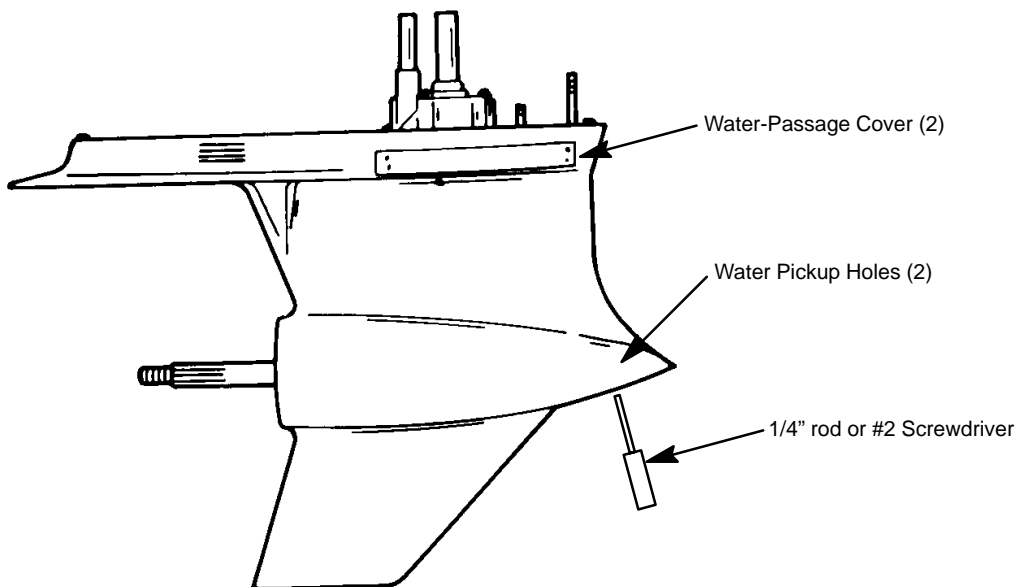
Engines in this serial number may have partial or full blockage of water intake holes in gear case.

Please inspect these engines for partially or full plugged water pickup holes as follows:

1. Trim outboard up.
2. Using a piece of 1/4" rod or #2 phillips screwdriver, try inserting through water intake holes.
3. If rod will not go in a minimum of 5", the holes are partially or fully plugged and must be cleaned. If so:
 - a. Remove both water passage covers.
 - b. Using a piece of stiff rod (welding rod) and a small ball peen hammer, break blockage loose. Do this operation through the pick up holes.
 - c. Blow air pressure through the pickup holes and flush any remaining debris out of passages.
 - d. Reseal water passage covers with Perfect Seal, and reassemble.
4. If rods will go in a minimum of 5", the holes are clear and no further action is required.
5. Submit a warranty claim for 0.7 hour labor and flat rate code NJC for each gearcase that must be cleaned out.
6. Contact all your registered owners and perform this inspection as soon as possible.
