Excessive RPM Force 40/50 HP

Models Affected

**1995, 1996 AND 1997 MODELS
STARTING SERIAL NUMBER 0E093728 AND
ABOVE.**

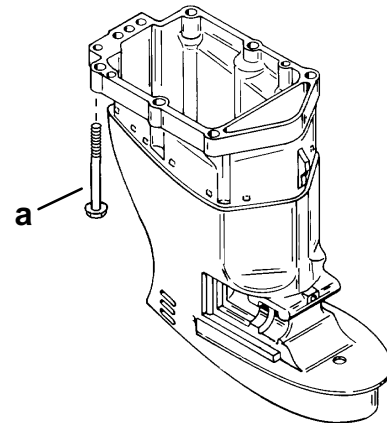
a - Driveshaft Housing to Powerhead Screws

1. Loose driveshaft housing to powerhead bolts.
2. Loose starter bolts and/or broken starter mounting flange.
3. Cylinder base gasket water leaks.
4. Fretting of mating surfaces on the powerhead and the adaptor plate.

1. Check that the engine RPM is within the operating range at wide open throttle with a normal load in the boat.
2. Check performance in normal turns. Does motor have a tendency to cavitate easily?
3. Check torque of driveshaft housing to powerhead screws. Torque should be 55 lb. ft. (75 N-m). Check other bolts on the powerhead if engine has operated above the top of operating range.
