## Cross Pins Missing – Single Ram Trim – 40/50 and 90/120

1998 40/50 and 90/120

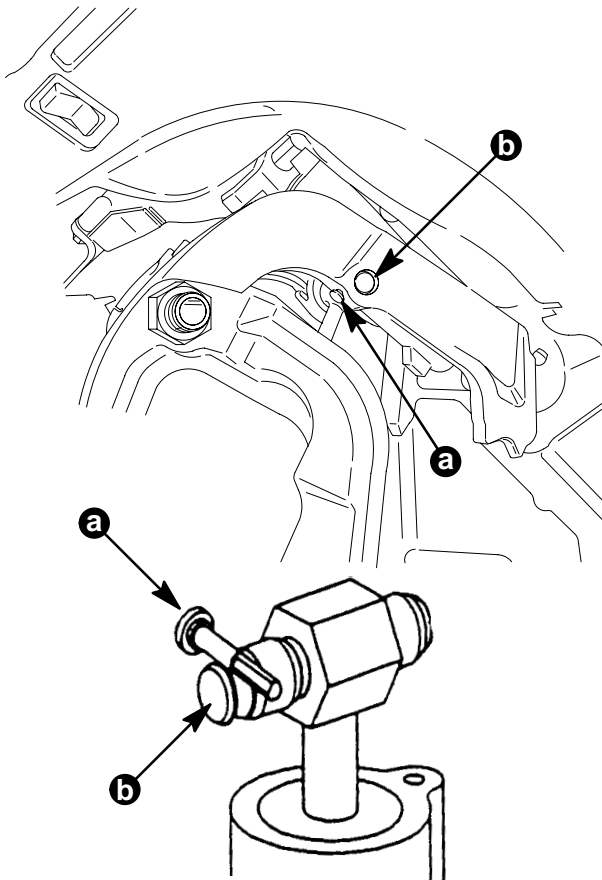
#### FORCE 40-50 UPPER CROSS PIN

Cross pin (a) **MUST** be installed through the groove in the pivot pin (b). The head of the cross pin **MUST** be seated against boss of swivel bracket.

Install missing or incorrectly installed cross pins.

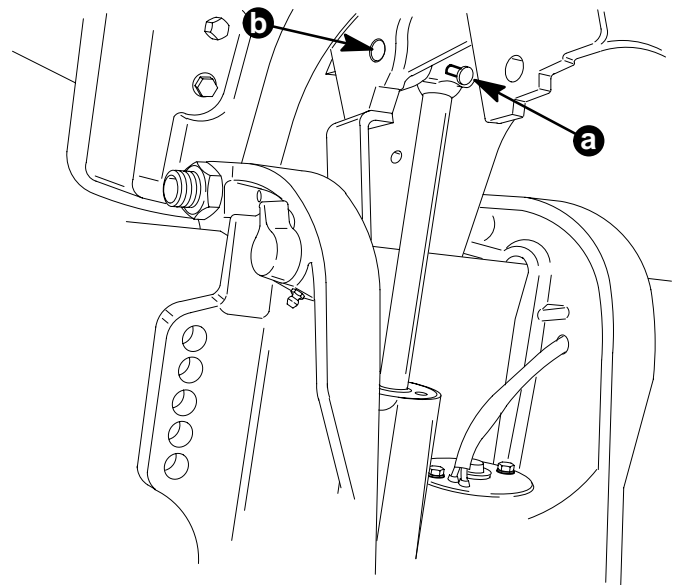
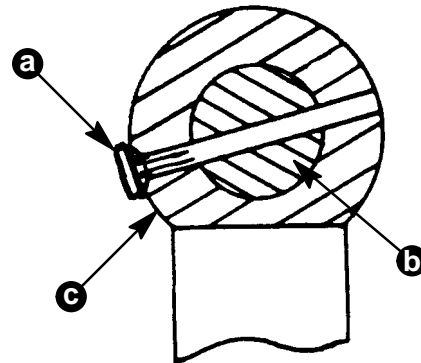
#### FORCE 90-120 UPPER CROSS PIN

Upper cross pin (a) **must** be installed through the hole in the pivot pin (b). The head of the cross pin **must** be seated against the rod eye.

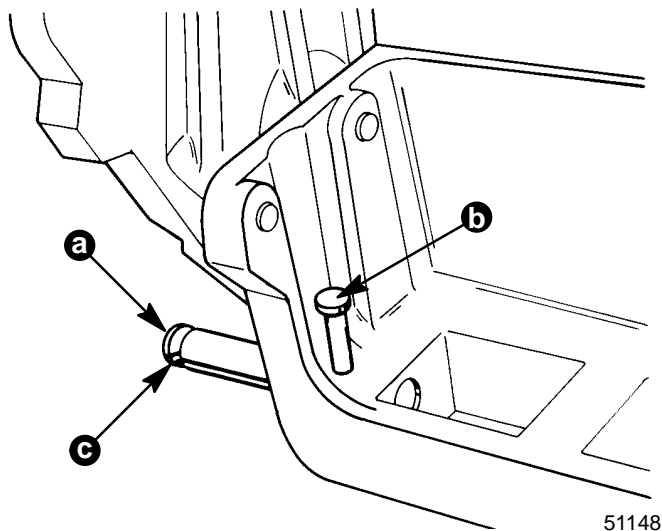
## FORCE 90-120 LOWER CROSS PIN

Lower cross pin must be installed through the groove in the pivot pin. The head of the cross pin must be seated against the casting.

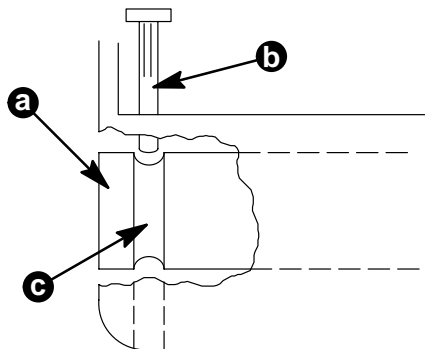
The head of the pivot pin is usually flush with the outside of the casting when the cross pin is aligned with the pivot pin groove.
