Official Notification - Federal Boat Safety Act Towershaft Lever Stop 1995 40/50 HP Models

1995 40/50 HP Models

S/N 0E093700 TO S/N 0E119819

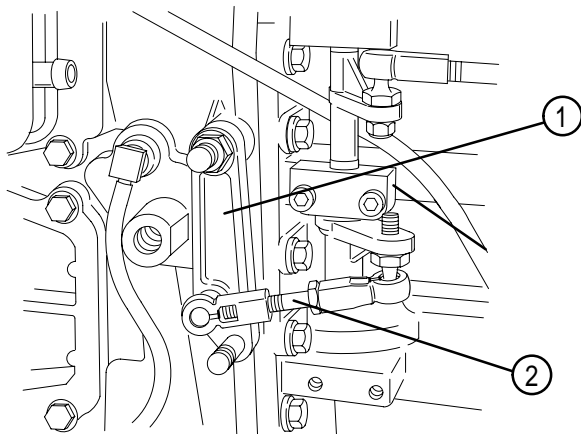
53761

A potential problem was found by Engineering while conducting performance tests. One of the ends of the towershaft lever link between the towershaft lever and towershaft could disengage during a hard acceleration maneuver causing loss of throttle control. As a result, we are initiating a recall pursuant to the Federal Boat Safety Act.

- 1 - Towershaft Lever
- 2 - Towershaft Link Assembly

A towershaft lever stop kit was designed to eliminate this potential problem. The part number for this kit is 830121A1.

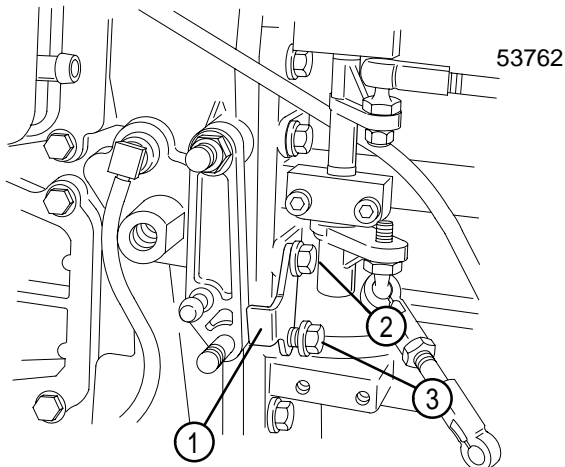
- 1 - Towershaft Lever Stop
 2 - Crankcase Cover Bolt (Loosen)
 3 - Crankcase Cover Bolt (Remove)

1. Advance engine to W.O.T..
2. Inspect position of throttle shutters: Ensure that shutters are horizontal $\pm 5^\circ$. Adjust throttle shaft link assembly as required. Return engine to idle position.
3. Disconnect towershaft link assembly from towershaft lever.
4. Remove lower crankcase cover bolt (3).
5. Loosen upper crankcase cover bolt (2).
6. Install the towershaft lever stop by positioning the top slot of the stop under the head of the upper bolt (2). Install the bottom bolt (3). Tighten both bolts securely.

7. Install bracket by positioning top slot under head of upper bolt (2). Install bottom bolt (3). Tighten bolts securely.

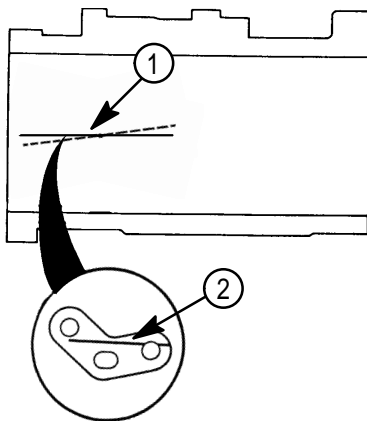
- 1 - Throttle Shutter
 2 - Line on Throttle Shaft

8. Advance engine to W.O.T.. Inspect position of throttle shutters: Ensure that shutters are horizontal $\pm 5^\circ$. Adjust throttle shaft link assembly as required.

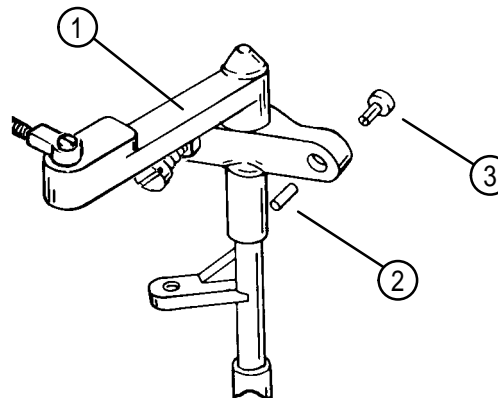
- 1 - Tower Shaft
 2 - Pin, Rivet
 3 - Rivet

9. Remove rivet stop at top of towershaft.

- Rivet can be drilled out or removed by placing a socket be-

hind rivet and using a punch to drive rivet pin out.
