Driveshaft Replacement 40/50

Models Affected

1995 Force 40/50
Serial Number
US 0E123524 thru 0E135075

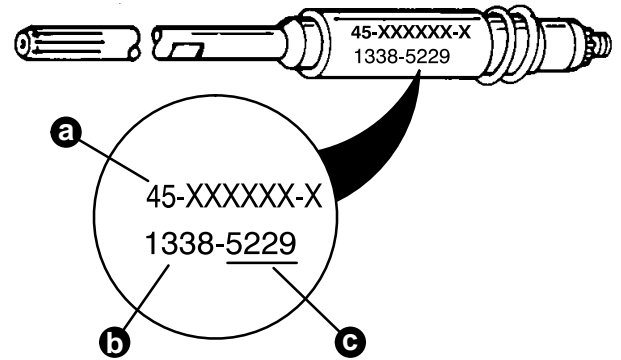
Figure 1. Driveshaft Date Code

The outboards listed may have driveshafts with defective welds. Endurance testing has discovered a small possibility of voids in the weld that joins the stainless steel upper section to the carbon steel lower section of the driveshaft. Operation of the outboard may result in early driveshaft failure.

- a - Driveshaft Part Number
- b - Manufacturing Number
- c - Date code

1. Remove gear housing and the driveshaft as outlined in the Outboard Service Manual.
2. Check the date code on the driveshaft per Figure 1.
3. Driveshaft **MUST BE** replaced if the date code is 5190 thru 5233.
4. Order Parts Kit p/n 809796A1 and driveshaft (if required) per this bulletin for reassembly.
5. Reassemble and install the gear housing as outlined in the Outboard Service Manual.
6. Fill the gear housing with Quicksilver gear lube, install the propeller, and check for proper operation of the outboard.

1. Check outboard and/or shipping carton within the affected serial number range for factory rework identification markings.
2. Outboards that have not been reworked at the factory within this serial number range must have the gear housing replaced. As an alternative, the driveshaft must be inspected and replaced if the date code is 5190 thru 5233 (Figure 1).
3. For Assistance:

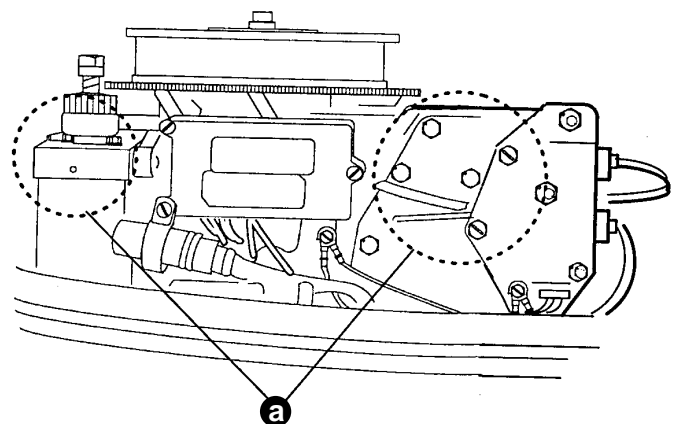
Figure 2. 40/50HP Rework Marking

- A red or black letter "D" hand applied with a marker on the outboard serial number label of the shipping carton.
- A yellow dot or marking painted on the powerhead (Figure 2).

- a - Yellow Paint Marking
