2.5L 200 OptiMax SportJet Air Compressor Reed Failure

Models Affected

Models Covered	Serial Number
2.5L 200 OptiMax SportJet	0E437737-0E438627
OptiMax and Pro XS replacement air compressors, Julian date codes 14189 through 16246	N/A

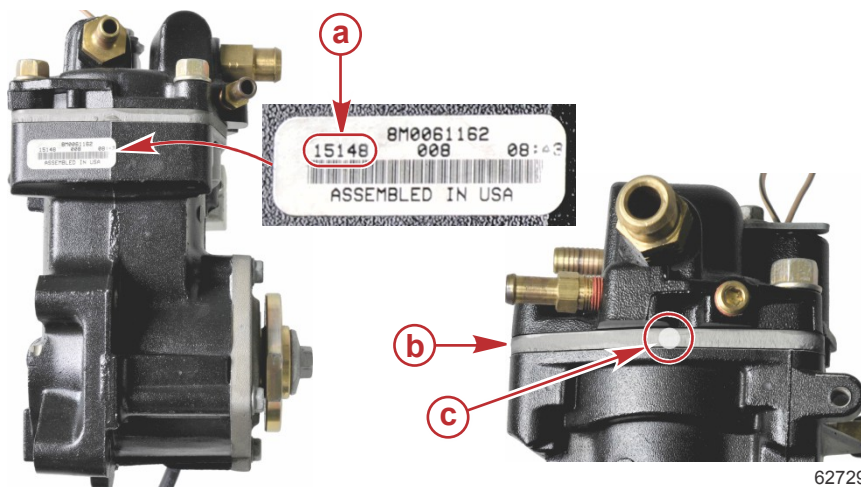
Air compressor

IMPORTANT: A white dot on the edge of the reed plate assembly indicates the reed plate assembly has been replaced. Do not rework a compressor with a white dot on the edge of the reed plate assembly.

Inspect all in-stock replacement air compressors. If no white dot is present and the Julian date code falls between 14189 (July 8, 2014) and 16246 (September 2, 2016), inclusive, replace the reed plate assembly.

- a** - Julian date code; codes 14189 through 16246 are affected
- b** - Reed plate assembly
- c** - White dot indicating that the reed plate assembly has been replaced and is not affected

Check the engine to confirm whether the air compressor is an affected unit. If no white dot is present and the engine serial number falls within the range specified at the top of this service bulletin, replace the reed plate assembly.

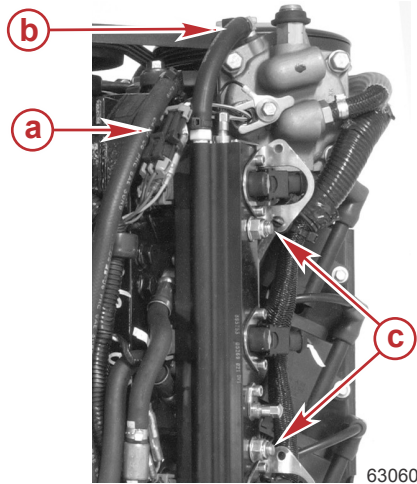
In order to access the lower left-hand screw on the air compressor cylinder head on 2.5L models, the port fuel rail must be temporarily disengaged and moved out of the way.

- a - Cylinder head temperature sensor harness connector
- b - Compressor water inlet hose
- c - Fuel rail mounting nuts (2)

1. Disconnect the cylinder head temperature sensor harness connector.
2. Disconnect the compressor water inlet hose.
3. Remove the two fuel rail mounting nuts.

4. Position the fuel rail out of the way, and complete the reed plate assembly replacement.

Before putting the engine back into service, be certain to reconnect all items and tighten the fuel rail mounting nuts to the specified torque.

Description	Nm	lb-in.	lb-ft
Fuel rail mounting nuts (2)	44.7	–	33

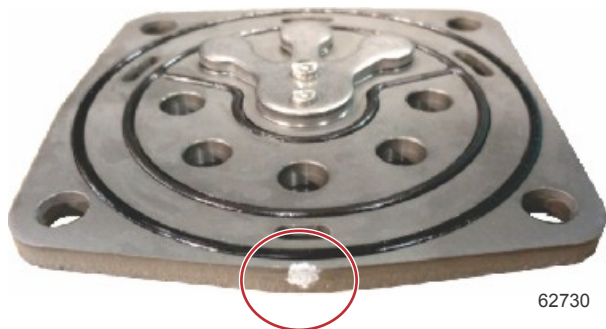
Reed plate assembly edge marked with a white dot

- To indicate that the rework procedure has been completed, mark the top edge of the replacement reed plate assembly with a white dot.
