Bulletin No. 2002-14

## Erratic Steering – Excel Models

All Excel Models

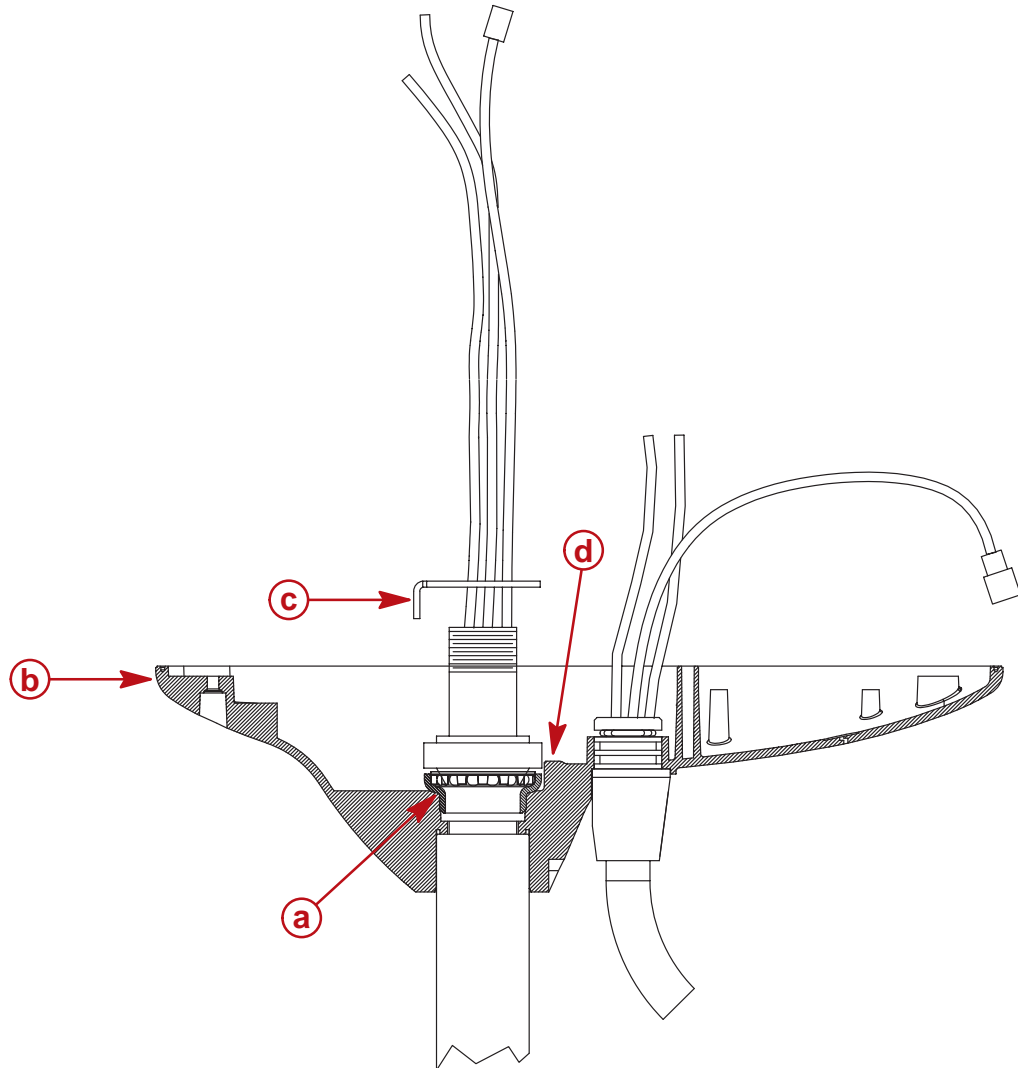
00177

If the steering performs erratically, it is possible that the steering bearing cup is not pressed completely into the lower housing base. This condition could manifest itself in two ways:

- a** - Bearing cup
- b** - Lower housing
- c** - Stop washer
- d** - Mechanical steering stop

Check the steering bearing cup in the lower housing. If it is not fully installed, press it into place and also replace the steering positioning pot (P/N 84-M01128). If when the bearing cup is properly installed, the stop washer turns past the mechanical stop, it is also necessary to replace the lower housing.
