Bulletin No. 2002-22

Mechanical Steer Foot Pedal (Tour Edition)

Model	Serial Number or Year
Tour Edition Models	2001, 2002, & 2003 MY 9B000294 – 9B164887

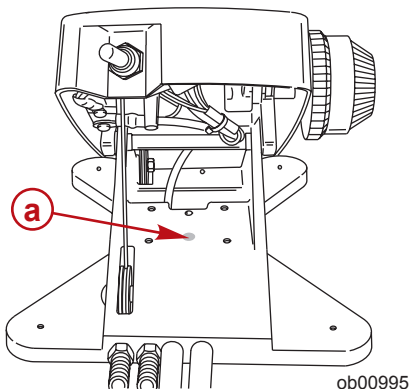
Figure 1

Tour Edition models that are within the affected serial number range should be inspected for a **white** dot as shown. The white dot indicates that the unit has been previously inspected.

a - White dot

A **white** paint dot must be applied to the foot pedal after completion of the rework as shown in Figure 1.

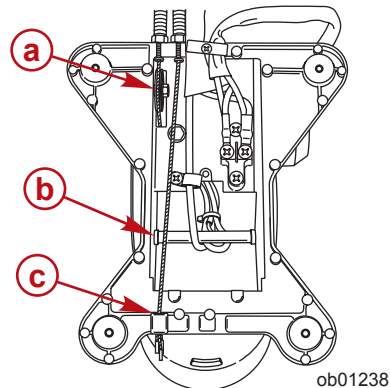
Figure 2

If the foot pedal assembly does not have the identifying mark, check the bottom side of the foot pedal. The e-clip securing the pivot pin should be located on the pulley side of the foot pedal. If the e-clip is located on the opposite side, the foot plate may contact the rear pulley which could cause the steering cable to slip off of it.

- a** - Front pulley **c** - Rear pulley
b - E-clip (correct position)

1. If the e-clip is located on the incorrect side, loosen the tension on the steering cables.
2. Remove the e-clip from the pivot pin and push the pin out.
3. Reinstall the pin ensuring that the e-clip end is on the same side as the steering pulleys.
4. Reinstall the e-clip on the pivot pin. Check to ensure that the steering cables are positioned on the pulleys and tighten the tension on the cables for proper operation. See Figure 2, preceding.
5. After the correction has been completed, apply a white paint dot to the foot pedal assembly.
