WARRANTY INFORMATION SERVICE INFORMATION

## Battery Discharge on HP500 EFI Engines

All HP500 EFI models prior to serial number 0L601357.

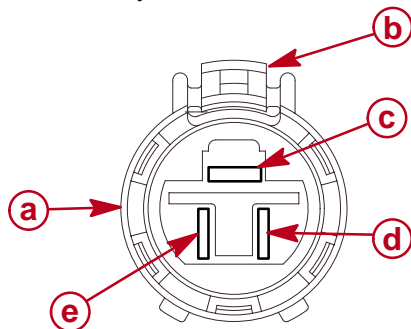
The engine wiring harness connector plug which attaches to the alternator was incorrectly assembled. The Red/Purple and Purple wires were reversed causing a greater than normal battery draw (in excess of 300 milliamps) with the ignition switch OFF. Normal ignition OFF draw is 20 milliamps.

- a** - Face of Wiring Harness Connector Plug
- b** - Connector Lock - Squeeze to Remove Connector Plug from Alternator
- c** - Terminal for Red/Purple Wire (Correct Location)
- d** - Terminal for Purple Wire (Correct Location)
- e** - Open

1. Remove the green wiring harness connector plug from the alternator by squeezing the connector lock and pulling on the plug. **Do Not Pull On the Wires going to the plug.**
2. Once removed, verify that the wires are in the wrong location.

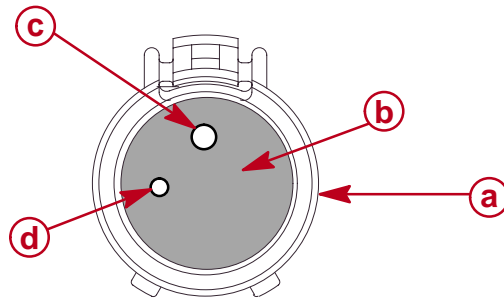
- a** - Connector Plug - Back View
- b** - Rubber Sealing Grommet
- c** - Red/Pur Wire (Correct Location)
- d** - Purple Wire (Correct Location)

1. Using a small flat blade screwdriver, pry the rubber sealing grommet out of the connector plug to expose the wires.

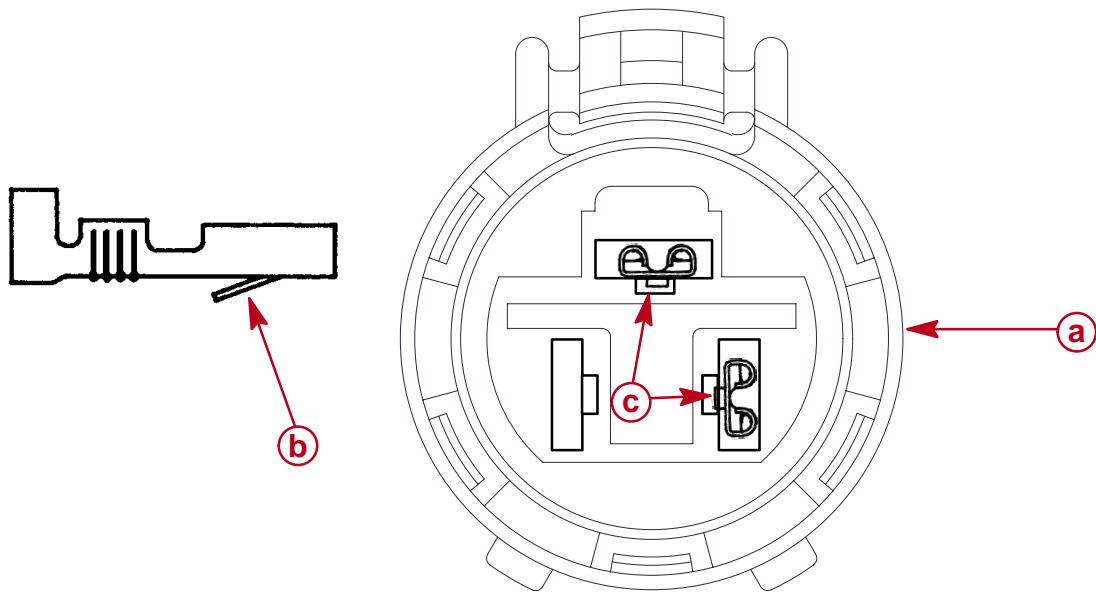
- a** - Connector Plug Face
- b** - Terminal Locking Tab
- c** - Terminal Release Slot

2. To release the locking tab on the female terminal, insert Snap On tool P/N TT600-5 into the terminal release slot on the face of the connector while pushing the wire forward in the connector. Once the tool is fully inserted and the tab released, remove the wire terminal from the connector plug. Remove second wire terminal from connector plug.

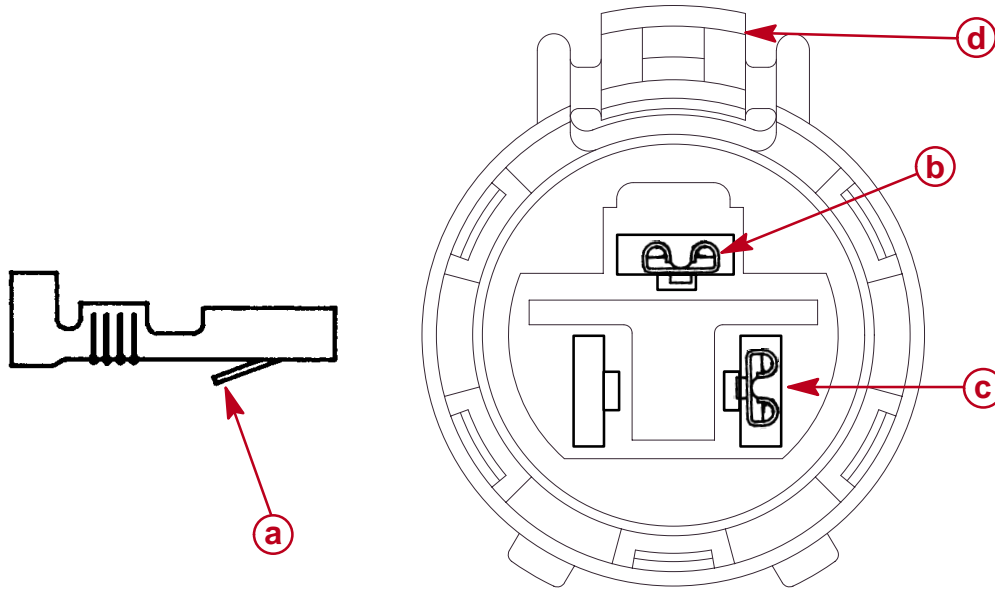
- a** - Locking Tab on Terminal - Pry Back Into Locking Position
- b** - Red/Pur Lead
- c** - Purple Lead
- d** - Connector Lock Release

3. Pry terminal lock tabs back into the locking position. Install the Red/Pur wire into the connector in the slot closest to the connector lock release and the Purple into the slot on the right side when looking at the face of the connector plug.
