▲ Revised May 2005. This bulletin supercedes the previous bulletin with the same title dated February 2005.

OFFICIAL RECALL NOTIFICATION U.S. FEDERAL BOAT SAFETY ACT - SHIFT LINK BAR CONTACT WITH THE BACK COVER OF BRAVO X / XR DRIVES

Models Affected

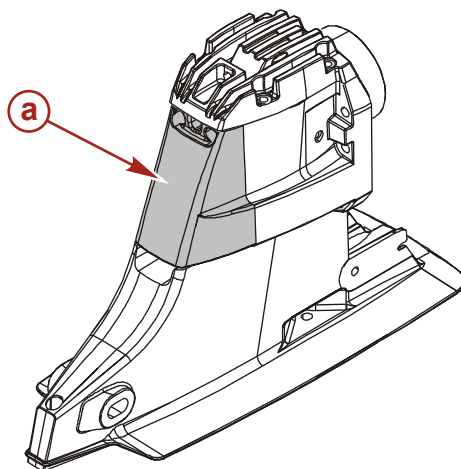
a - Rear cover affected by this bulletin

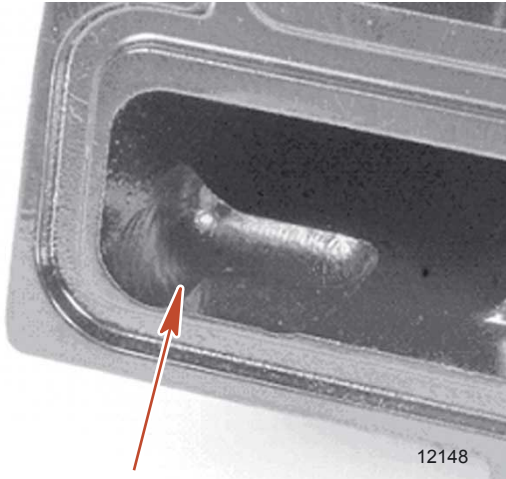
New cover with added link bar clearance

1. To inspect, the back cover must be removed from the drive and checked for evidence of contact from the shift link bar at the cotter pin area of the shift lever. The washer and cotter pin must also be inspected for any indentation marks on the washer from the cotter pin caused by heavy contact.
2. Replace the washer and cotter pin if required, then install the new back cover and seal from the replacement back cover kit. Using Special Lubricant 101, lightly grease the new detent ball canister and spring assembly and place it into the new back cover before installation.

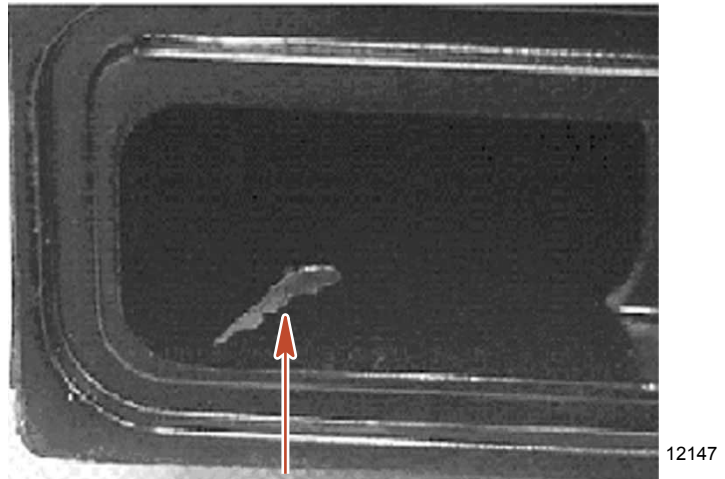
The shift link bar at the shift lever is making contact with the back cover of the driveshaft housing. The contact may cause the cotter pin to wear through, allowing the link bar to become disengaged from the shift lever, resulting in loss of shifting control. In right-hand rotation models it is also possible that the cone clutch could be prevented from engaging properly into the gear socket, resulting in the cone clutch being stuck in gear.

Contact area from link bar

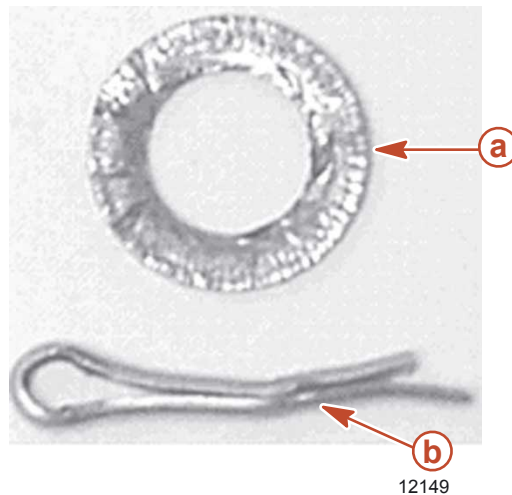
If the drive unit has been operated 30 hours or more, inspect the washer on the link bar for indentation marks from the cotter pin. If there are indentation marks on the washer, change both the washer and the cotter pin before installing the new rear cover.

a - Area of indentation marks on the link bar washer

b - Wear area on the link bar cotter pin

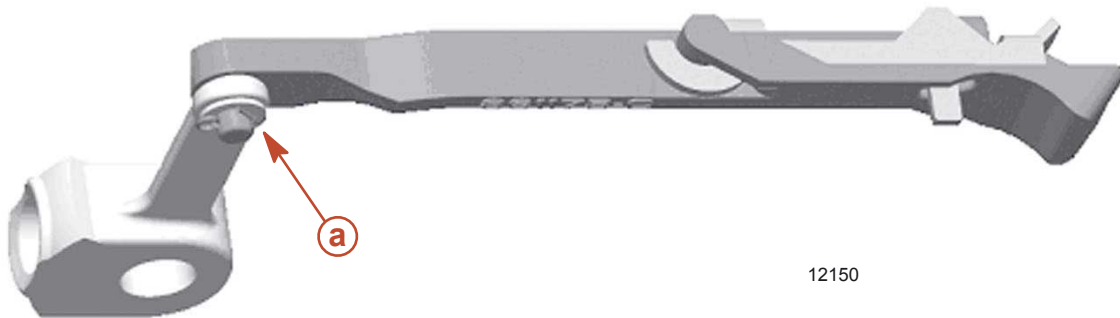
a - Washer and cotter pin
