## Oil Injection Gear Failures – Sport Jet 175XR<sup>2</sup>

### SPORTJET

175 hp Model  
Serial Number 0E203000 & up

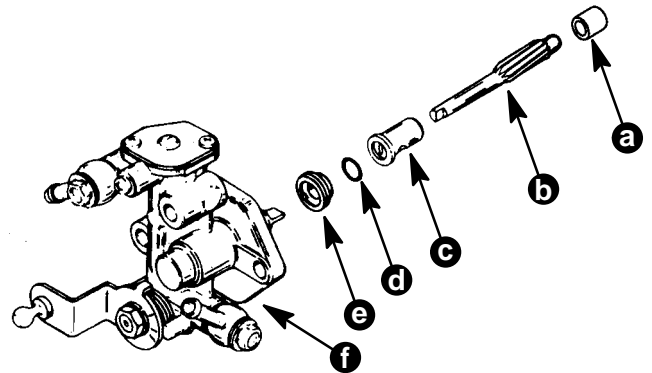
- a - Oil Pump Driven Gear Bushing Located in Cylinder Block
- b - Driven Gear
- c - Drive Gear Bearing Assembly
- d - O-Ring
- e - Worm Bushing
- f - Oil Pump

- If the cylinders are not damaged, replace the oil injection check valve, the crankshaft mounted drive gear, the driven gear, the drive gear bearing assembly, and the oil pump with worm bushing and o-ring. Thoroughly clean the crankcase and bleed system, inspect bronze bushing in cylinder block for damage, and check the warning horn system for proper operation.

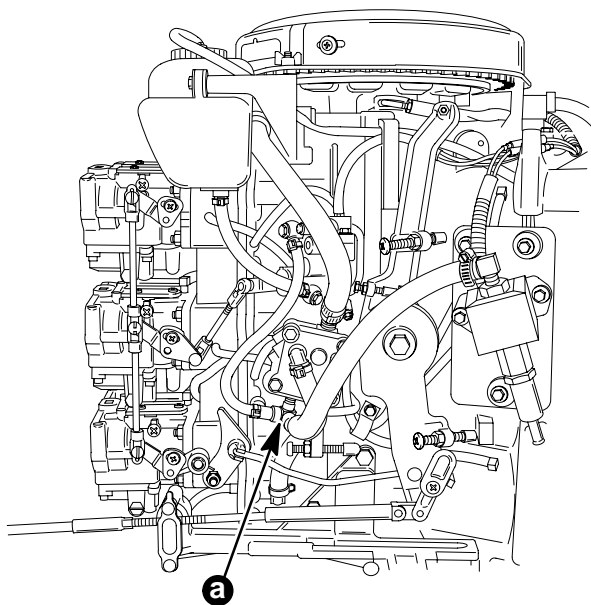
## Check Valve Location

a - Check Valve

- If the cylinders are damaged, repair or replace powerhead as appropriate, replace the oil injection check valve, oil pump, drive gear bearing assembly, and driven gear. Check the warning horn system for proper operation and instruct the customer on proper break-in procedure.
