OptiMax Air Compressor Hub Runout

Models Affected:

Models Covered	Serial Number
75 – 115 HP; 1.5 Liter OptiMax	SN 1B445150 through 1B446575
135 – 200 HP; 2.5 Liter OptiMax	SN 1B445150 through 1B447802
200 – 250 HP; 3.0 Liter and Pro-XS OptiMax	SN 1B445150 through 1B447437

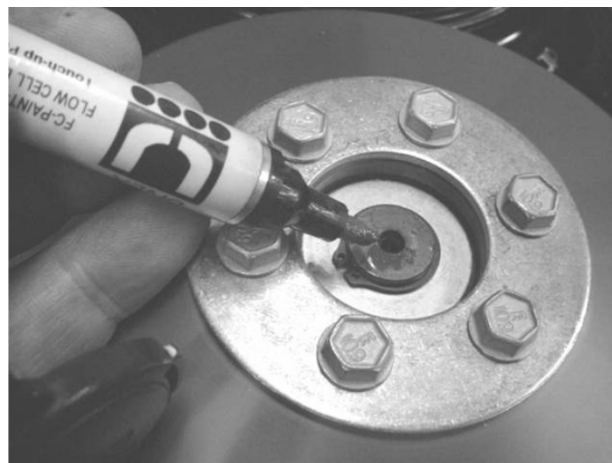
27068

2. Remove the flywheel cover and inspect the compressor for a blue dot as shown. It must be a blue dot.

- If a blue dot is present, no further action is required.
- If a blue dot is **not** present, continue with Step 3.

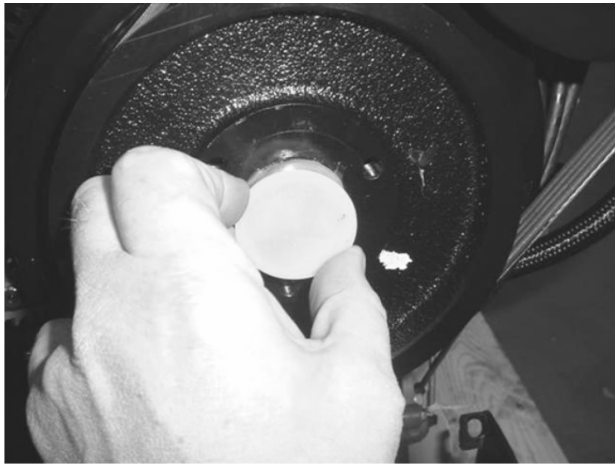
27069

3. Remove the yellow cap over the flywheel nut.

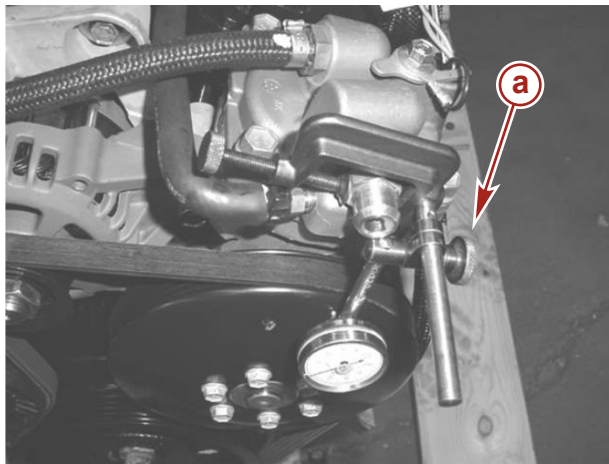
27070

a - Clamp

IMPORTANT: The clamp must be tight and secure on the mounting fitting.

- Adjust the dial indicator on the secondary clamp arm. The indicator tip must be in contact with the pulley at a point approximately 9.5 mm (3/8 inch) from the outer rim of the pulley, where the radius turns down toward the belt.

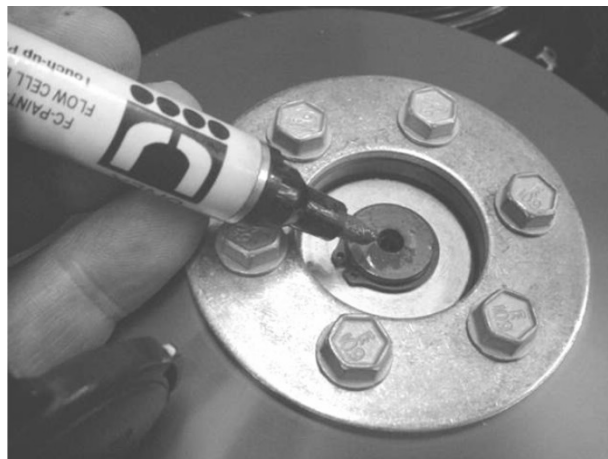
27068

- **If Passed:** (TIR less than 0.020 in.) Go to Step 7.
 - **If Rejected:** If the above runout condition is above specification, the compressor unit complete will require replacement. Ensure the replacement compressor is not within the affected Julian date code range. Then, continue with Step 7.
7. Mark the inspected and passed engine with a blue paint mark on the compressor pulley shaft.

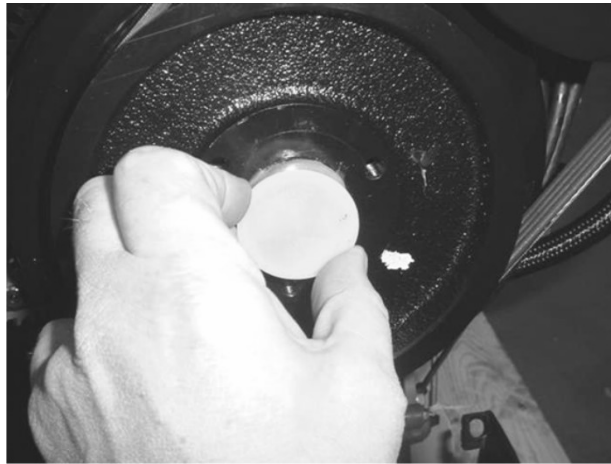
27069

8. Replace the yellow cap seal over the flywheel nut.
