Supercharger System Troubleshooting—Verado L4 and Verado L6

NOTICE
This bulletin supersedes the previous service bulletin number 2009-16, November 2009.

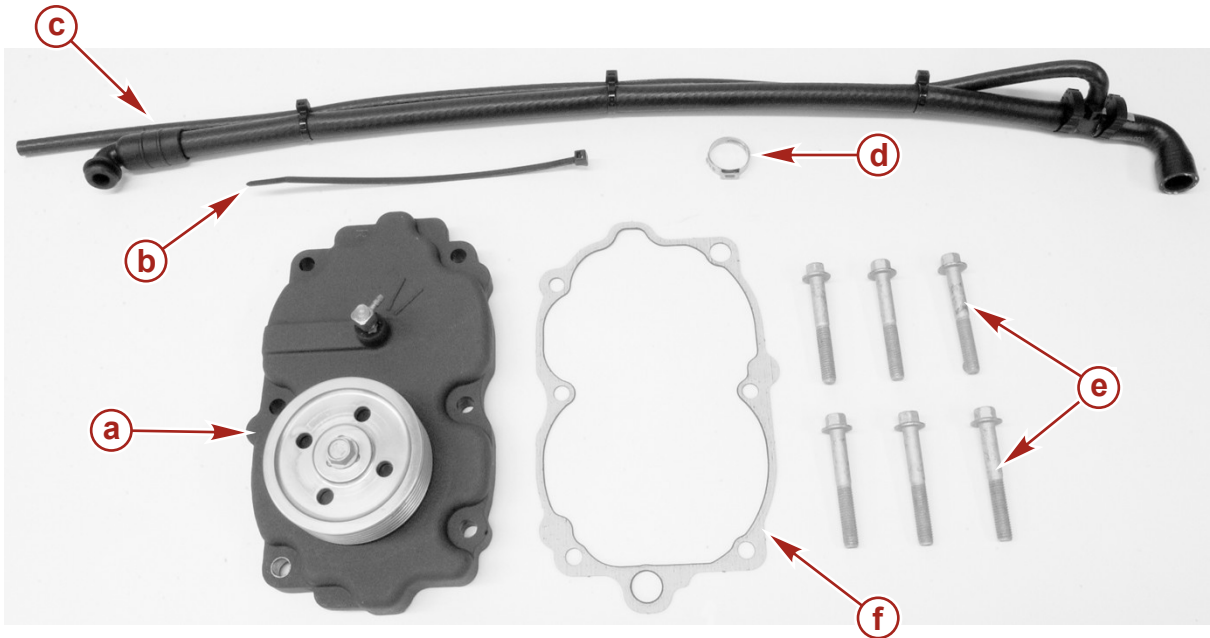
25676

Supercharger end cap kit (8M0045222)

- If an oil leak is observed from porosity in the supercharger end cap, install the supercharger end cap kit (8M0045222).
- If an oil leak is observed at the upper crankshaft seal, replace the upper crankshaft seal.

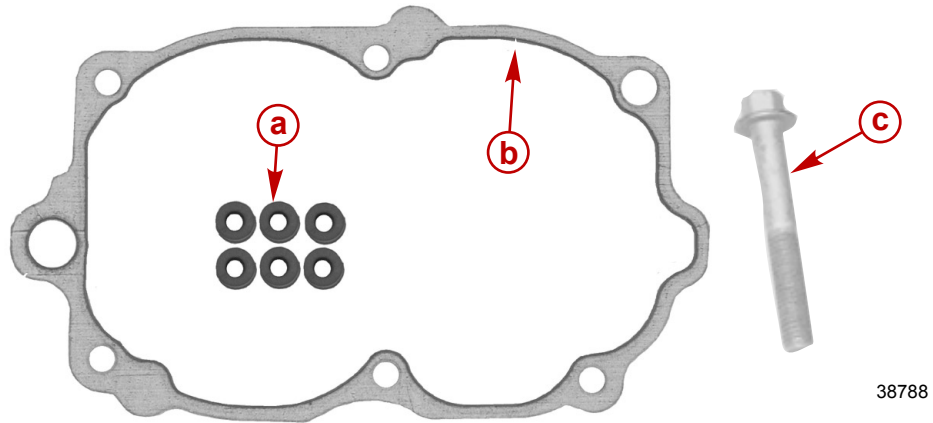
38788

Supercharger bushing kit (847803A02)

- If an oil leak is observed at the supercharger bearing housing to end cap joint due to a bad gasket, install the supercharger bushing kit.
