STERN DRIVES/INBOARD ENGINES

service bulletin

NUMBER: 82-5

TROUBLESHOOTING THE COOLING SYSTEM ON MERCUISER 4 CYLINDER 224 CID ENGINES (MCM/MIE 470, MCM 485 and MCM 488)

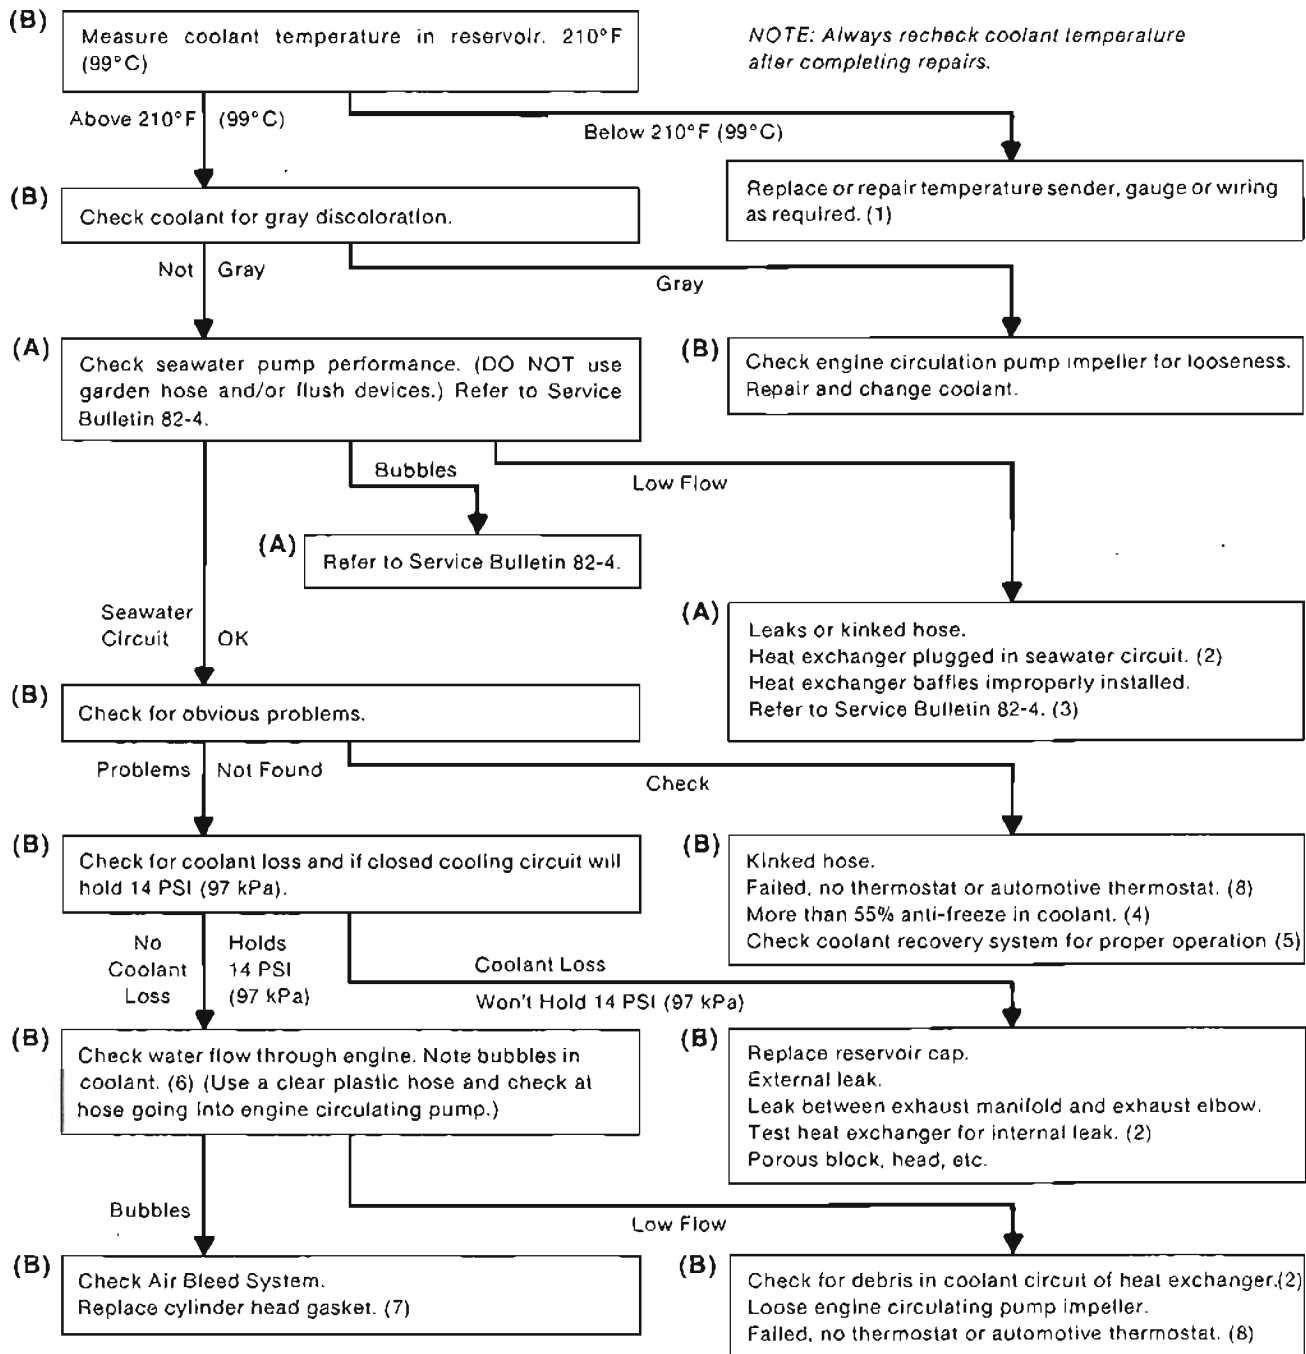
Although the cause of trouble can occur individually, two or three of them usually show up together. All result in an increase in engine temperature. In the following Chart, (A) refers to the seawater circuit and (B) refers to the closed cooling circuit.

NOTE 1: Normal operating engine temperature taken at the water temperature sender with a direct reading gauge is 165°F (74°C) to 200°F (93°C) at W.O.T. Dual station boats must use a dual station water temperature sender.

NOTE 3: MIE seawater pump flows 30-32 Gal/Min. at 4200 RPM.

NOTE 4: % of anti-freeze in coolant can be checked with anti-freeze tester.

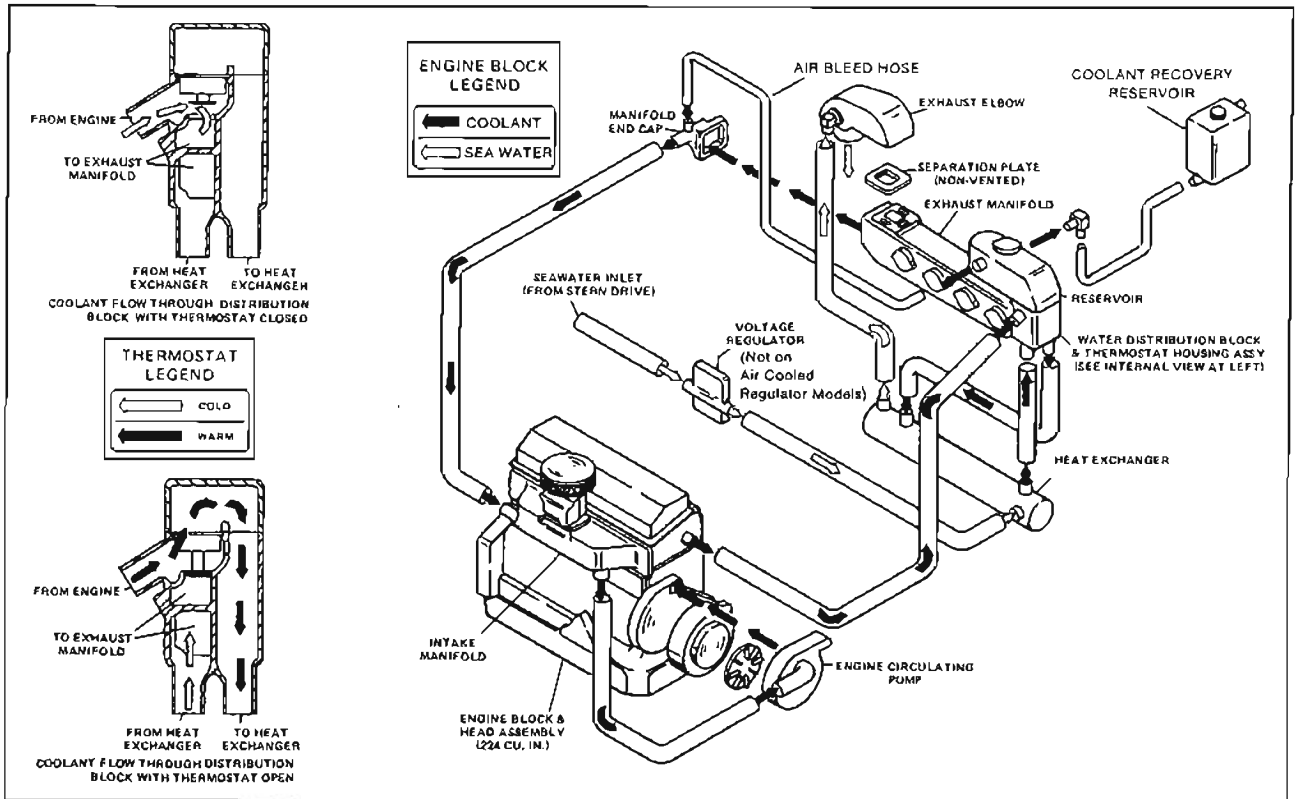
Figure 2. MCM 470 Water Flow Circuits [With 3" (8cm) Dia. Heat Exchanger]

IMPORTANT: The end castings directs the seawater flow through the heat exchanger in Stern Drive (MCM) Engines. If they aren't installed correctly, the water takes a short cut and two-thirds (or more) of the exchanger is not used.

- **Stern Drive (MCM) Engines with a 3" (8cm) Dia. Heat Exchanger: Seawater passes through exchanger three (3) times before leaving.**
 - **Stern Drive (MCM) Engines with a 4" (10cm) Dia. Heat Exchanger: Seawater passes through exchanger five (5) times before leaving.**
 - **Inboard (MIE) Model Engines: Seawater passes through exchanger once before leaving.**
- b. Internal leaks can be repaired by soldering shut the ends of the leaking tube. This is only a temporary fix because usually another tube will start leaking after a short period of time and this also causes a reduction in cooling capacity. DO NOT close more than 3 tubes.
 - c. Nipples and drains that have been broken off the heat exchanger can be re-attached by brazing. Care must be taken not to melt other joints during repair.
