Bulletin No. 2001-06

## ▲ Required 496 MAG / 496 MAG HO / 8.1S / 8.1S HO Push Rod Replacement

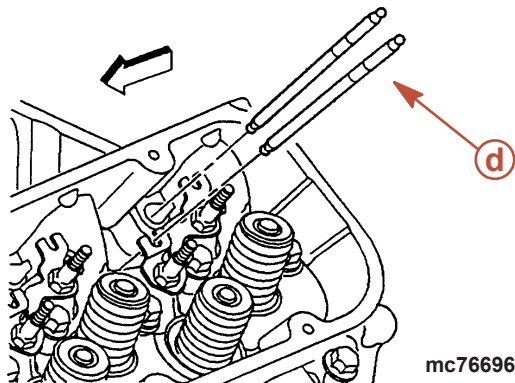
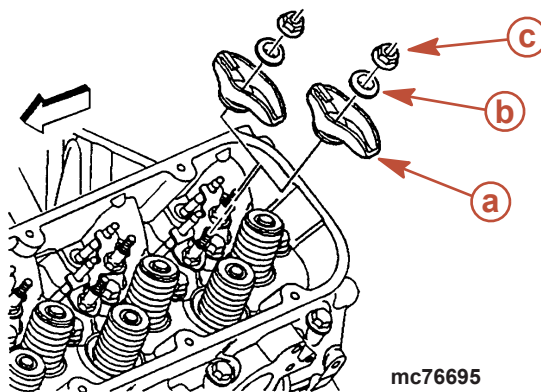
- a - Rocker arms
- b - Rocker arm balls
- c - Nuts
- d - Push rods

2. Install rocker arm assemblies in their original locations.

3. Torque rocker arm nuts slowly to 25 Nm (19 lb-ft).
