Zeus Design 2 Joystick Inspection and Software Reflash

NOTICE
Revised August 2018. This bulletin supersedes the previous bulletin number 2017-62, July 2017.

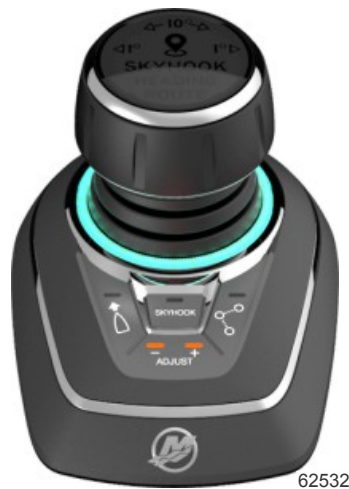
Design 2 joystick

NOTE: Zeus pods within the serial range defined above may be installed on vessels with design 1 joysticks. This bulletin only applies to vessels that are equipped with design 2 joysticks.
