3000 Series Zeus Pods Product Improvement – Corrosion Prevention Enhancements

NOTICE
This bulletin supersedes the previous service bulletin number 2013-64/OEM 2013-63 June 2013.

Models Affected

Models Covered	Serial Number
Zeus Models HH, IH, JH, and KH	Prior to serial number 0M969460

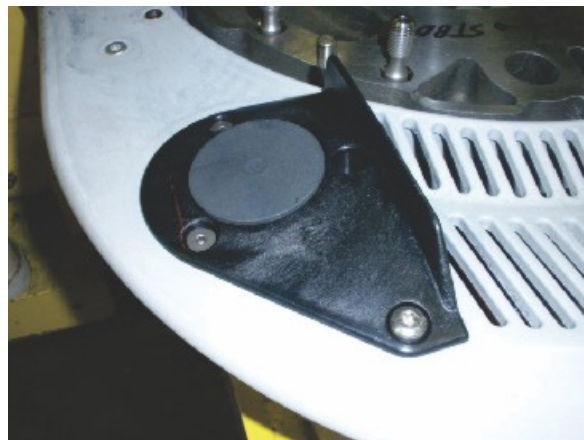
53063

1. MerCathode anode assembly – replace the existing anode assembly with the new anode assembly which contains a deflector shield.

NOTE: The new anode assembly requires the use of the backing plate assembly. If this is either not present or needs to be replaced, please order backing plate assembly 8M8025265. For further information, refer to Service Bulletin 2010-72.

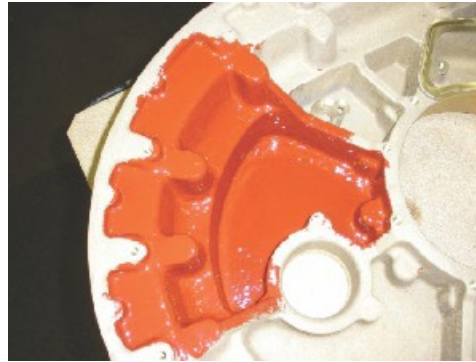
53064

- Midsection plate – apply a ceramic coating to the respective portion of the bronze midsection plate as shown below.

Qty.	Description	Part Number
1	MerCathode anode assembly (one per pod)	8M0074249
1	Ceramic coating kit (kit can coat 10–12 pods) <i>NOTE: Use only if no sign of pitting or pinhole corrosion is present in the midsection plate cavity that is shown above. For reference, see Mercury Diesel Service Bulletin 2012-70R1.</i>	8M0082937

Qty.	Description	Part Number
1	Putty/ceramic coating kit (can repair 4–5 pods) <i>NOTE: Use if pitting or pinhole corrosion is present in the midsection plate cavity that is shown above. For reference, see Mercury Diesel Service Bulletin 2012-70R1.</i>	8M0074256
1	Backing plate assembly (if needed) <i>NOTE: For reference, see Service Bulletin 2010-72.</i>	8M8025265
